Manhole Inspection Summary

Manhole # S11WW_007MH

Insp Date: **7/10/09 11:02 AM**

Location Address: **3402 HILTON RD**

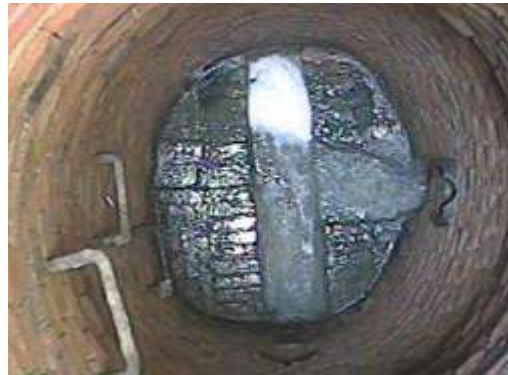
Top View

DEBRIS ON BENCH

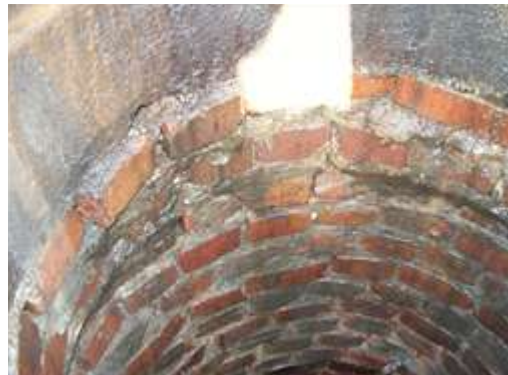
Defect 2

Condition: ☐ Sound ☒ **Cracked** ☐ Root Intrusion ☐ Loose Brick ☒ **Deteriorated**

CRACKED/DETERIORATED CORBEL

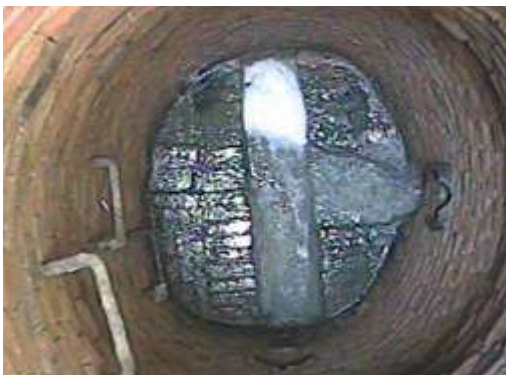
Defect 1

Count: **5** Missing: **0** ☒ **Corroded**

CORRODED STEP

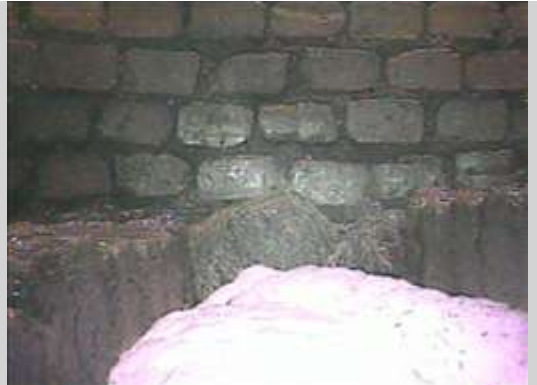
12 O'Clock Outflow

10 in. Circular Gravity Sewer
Pipe Out @ 12 O'Clock

POSSIBLE ROOT INFILTRATION

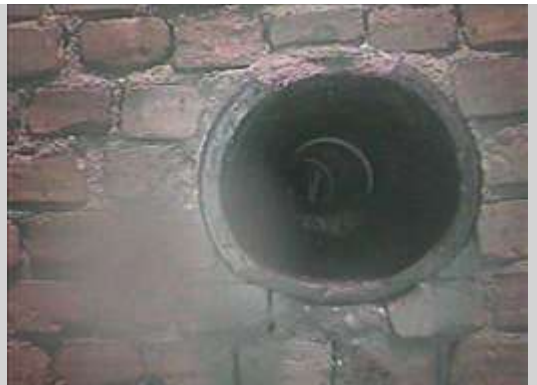
3 O'Clock Inflow

Pipe Height: (in.) Direct
Pipe Material: **Clay** ☐ Pipe Lined
Invert Depth: **10.74** (ft.) Flow Characteristics: **Fast**
Deposits: ☒ None ☐ Mud ☐ Sludge ☐ Debris ☐ Grease
Silt Depth: (in.) Deposits Extent:
Infiltration: **None** Pipe Seal Cond: **Broken**

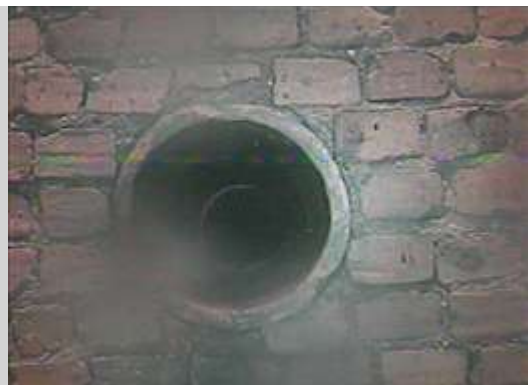
6 O'Clock Inflow

POSSIBLE ROOT INFILTRATION

Infiltration: **None** Pipe Seal Cond: **Broken**
